**REMOVAL REPORT
For
DIAZ INTERMEDIATES CORP.**

**301 WYANOKE ROAD
WEST MEMPHIS, CRITTENDEN COUNTY, ARKANSAS 72301**

U.S. Environmental Protection Agency Region 6
1445 Ross Avenue
Dallas, Texas 75202

Dynamac Corporation
1202 Executive Drive West
Richardson, Texas 75081
(214) 575-3344

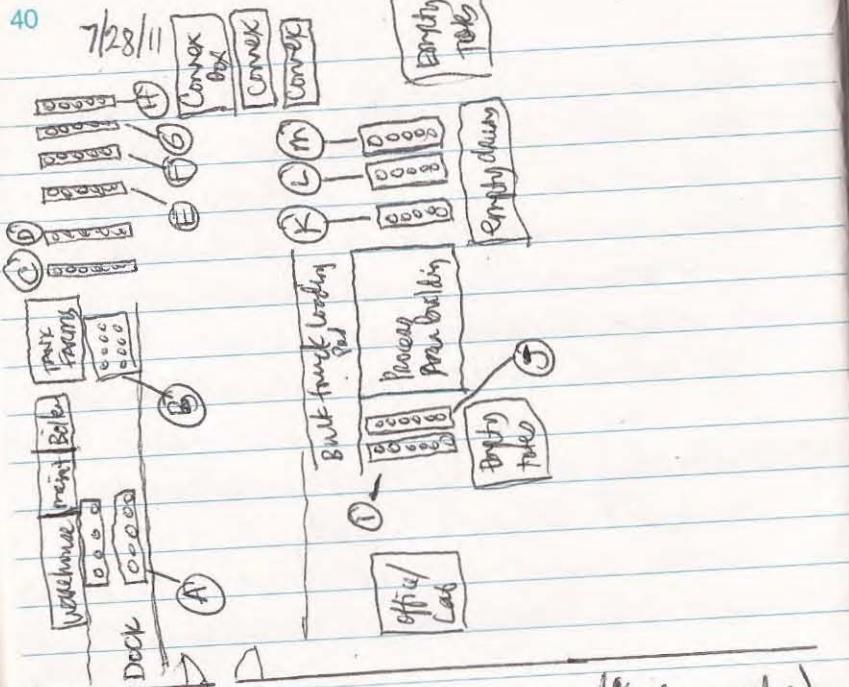
- (A) m-Bromoanisole (Count: 90 clear / 16-brown color)
- (B) Toluene (3 rows) (Count: 311 drums)
- (C) Toluene (5 rows)
- (D) Benzene (3 rows) (Count: 188 drums)
- (E) Propyl-bromide (1 row) (Count: 44 drums)
- (F) Toluene totes (2 rows) (Count: 21 totes)
- (G) Benzene totes (2 rows) (Count: 22 totes)
- (H) Methyl totes (1 row) (Count: 23 totes)
- (I) Neutralizers & p-Bromoanisole (Count: 42 drums)
- (J) HBr (Count: 64 drums / 7 totes)
- (K) HCl (Count: 56 drums)
- (L) Unknown mixed organics

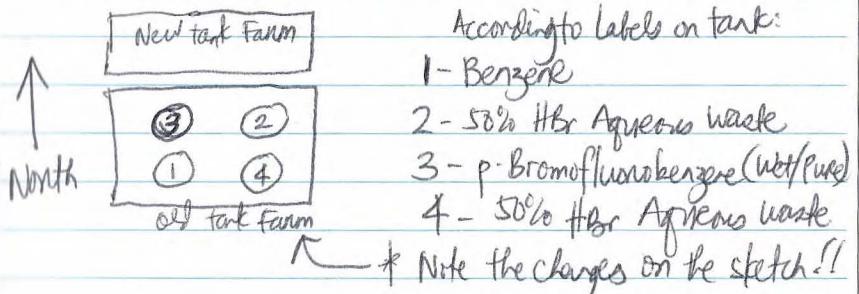
map sketch should look & be modified to:

According to labels on tank:

- 1 - Benzene
- 2 - 50% HBr Aqueous waste
- 3 - p-Bromofluorobenzene (Wet/Pure)
- 4 - 50% HBr Aqueous waste
